Framing Failures in Wood-Frame Hip Roofs under Extreme Wind Loads

Sarah A. Stevenson¹, Gregory A. Kopp^{1*} and Ayman M. El Ansary²

Stevenson SA, Kopp GA and
El Ansary AM (2018) Framing Failures
in Wood-Frame Hip Roofs under
Extreme Wind Loads.
Front. Built Environ. 4:6.
doi: 10.3389/fbuil.2018.00006

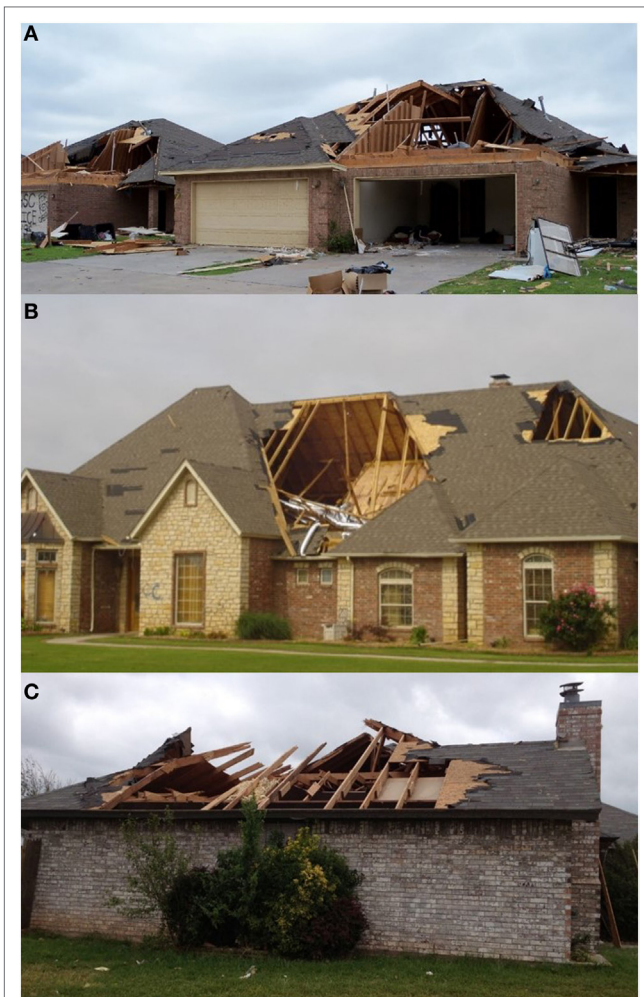
Figure 3A shows neighboring hip-roofed homes that exhibit similar failures of the front face of the roof. The RTWCs appear to be intact around the remaining perimeter of the roof and it is apparent that several members of the roof frame have failed or been removed, in addition to the sheathing covering this portion. At the right side of the photo, the remaining part of the roof is sagging, which further indicates that the underlying frame has failed. The houses shown in **Figure 3A** were located along Kyle Drive at the western edge of Moore, OK. Several houses along this short stretch had similar failures of hip roof framing and were built around 2006 (Graettinger et al., 2014). Inspection of the damage photos from this neighborhood indicate that, of houses experiencing DOD-4 or DOD-6 roof damage, 40% appeared to have failed through similar partial failures. In these cases, it appears that the frame failed at the nailed connections between the members, as no broken lumber is visible. The following section will present additional statistics and observations from two selected neighborhoods following the Joplin, MO tornado.

FIGURE 3 | Hip roof failures in Moore, OK following the EF5 tornado of May 21, 2013. **(A)** Failure of front face of neighboring, stick-frame hip roofs. **(B)** Failure of front face of stick-frame hip roof, with intact framing of opposite face visible. **(C)** Framing and sheathing failure in combined hip/gable roof (image source: Dr. David Prevatt).

Figure 3B shows a failure similar to that in **Figure 3A**, but of a much steeper roof. The RTWCs appear to be intact, and a large open cavity is visible where both framing members and sheathing have been removed. Similar to **Figure 3A**, it is apparent that this roof did not exclusively suffer sheathing loss, although the smaller area of sheathing loss at the right side of the photo should be noted. The lack of visible internal members in the cavity, especially those supporting the intact opposite face of the roof, strongly suggest that this roof was built as a stick-frame structure as opposed to the one containing prefabricated trusses. Many of the failed hip roofs in the available data appear to have used stick framing.

Figure 3C shows a partial failure of a combined hip/gable roof. This failure is unique from those shown in **Figures 3A,B** because material failure of the wood members is apparent. The RTWCs appear to be intact, with the lower part of the

roof having lost only sheathing on the right side and framing members, in addition to sheathing, on the left. Near the peak of the roof, the frame has failed on both faces. This structure appears to contain either trusses or stick framing with robust connections. As indicated in the figure just above the RTWC, the members were connected or otherwise reinforced using nailed wooden plates.

Upon inspection of the failures shown in **Figure 3** and similar damage in the available photos, it becomes apparent that partial framing failures are possible, repetitive modes of failure occurring in hip roofs. When comparing these hip roof failures to nearby structures from the data, it was determined that framing failures may govern in some hip roofs at EF2 wind speeds, rather than RTWC failures or sheathing loss. It is also noted that the construction of the roof may be important. The observed stick-frame failures especially suggested that the performance of stick-frame roofs should be distinguished from that of trussed structures in analysis and design, as well as in the present research.

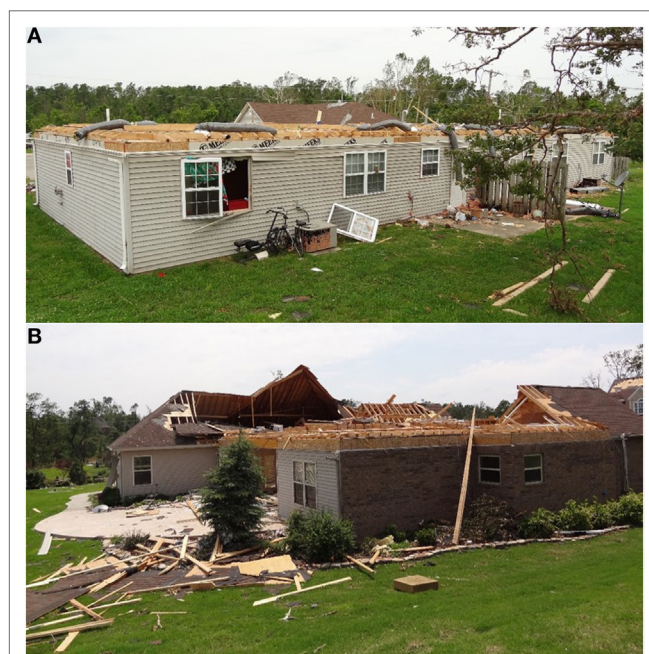
In Figure 11, partial framing failure and removal of large sections of the roof appears to have occurred. Upon closer inspection, however, it becomes apparent that the ceiling joists and the ceiling beneath them are intact. Only the external rafters and attached sheathing have been removed or damaged. Based on the results of the D/C analysis for the stick-frame case, this type of failure is unlikely, due to the relatively robust connection between the rafter and the ceiling joist. The RTWC and the connection along the ridge of the roof appear to be much more vulnerable in analysis, in comparison to the seven-nail joint previously mentioned. The pictured failures may have occurred due to improper or missing fasteners between the rafter and the joist at the wall top plate or initiated as failure of the upper rafter joint. Additionally, system effects may have led to progressive, cascading failure of adjacent

FIGURE 11 | Examples of partial stick-frame, hip roof failure with ceiling joists intact. **(A)** Complete removal of outer roof framing. **(B)** Partial removal of several faces of the roof (image source: Dr. David Prevatt).

joints, resulting in removal of entire faces of the roof following initiation at a single point.

The failures shown in **Figure 11**, and many other similar failures, are interesting because they would be objectively classified within DOD-6 for residential roofs; however, this may be an inaccurate assumption. This is an important point for further exploration because it may influence refinements to the EF-Scale for different residential design methods, or even suggest a new DOD for stick-frame structures.
